PALAEONTOLOGICAL AND EROSIONAL REVIEW OF BEDROCK EXPOSURES
WITHIN THE PERIPHERY OF THE OLDMAN RIVER RESERVOIR

Report Prepared for Alberta Environmental Protection, Natural
Resources Service Prairie Region, Water Management.

Report completed October 25, 1996

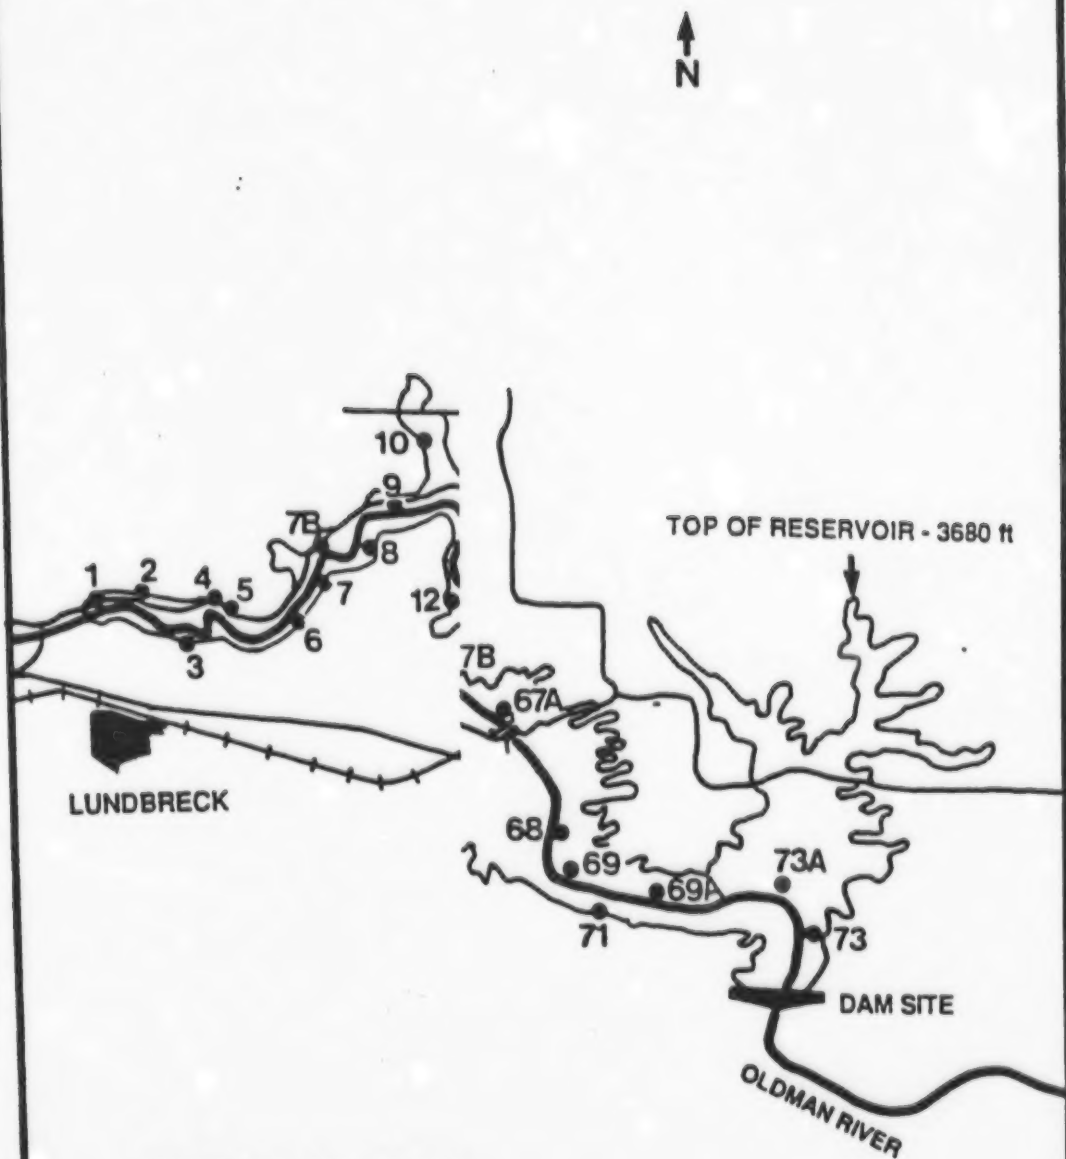
FIGURE A1. Map showing
 1 to 73 along the Cr
 rivers. All localit
 by analysis of air p

FIGURE 1. Figure 1 is a reproduction of Figure A1 from a report entitled "Paleontological Assessment for the Oldman River Dam Mitigation/Opportunities Plan" completed by Carbex Geological Services Ltd. on December 28, 1987. A large majority of these localities were revisited as part of this palaeontological review, (see also Maps 1-10).

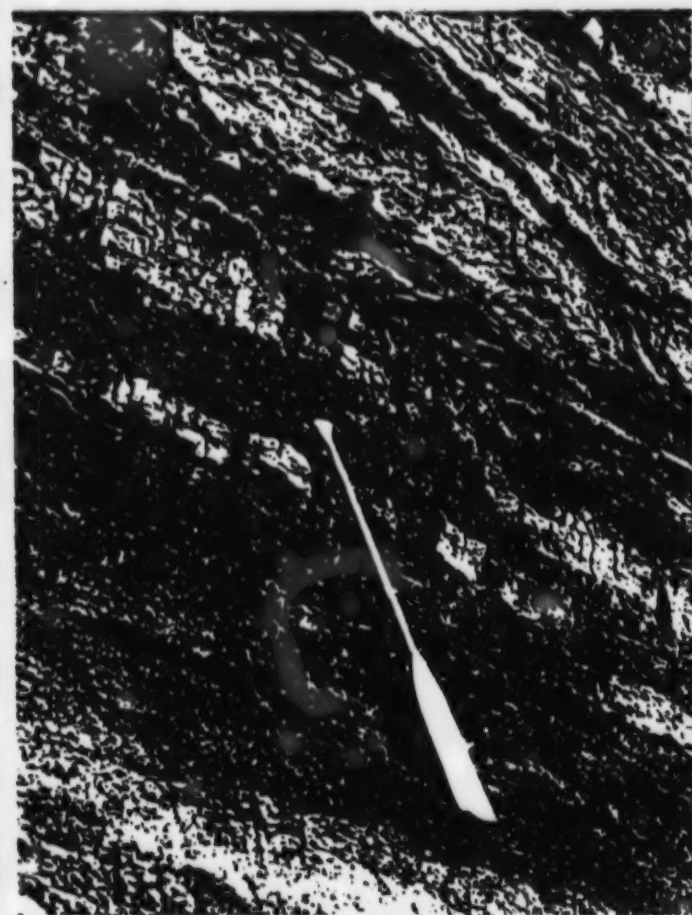
Photograph 18: Honey-combed cross-bedded sandstone of the Willow Creek Formation at locality 19. The paddle is 1.36m long.

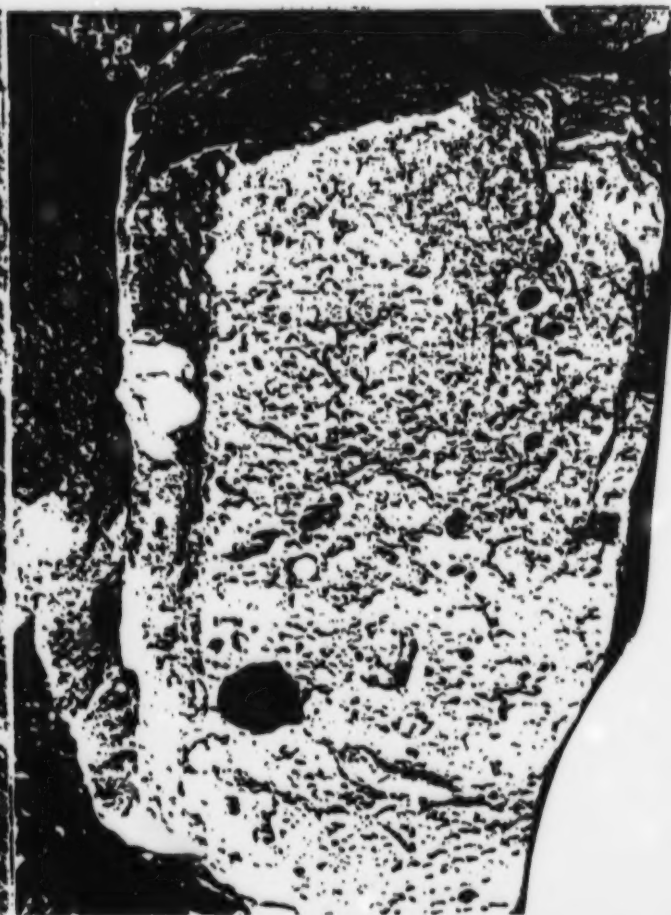
Photograph 19: Looking south at an eastward dipping exposure near the contact between the Willow Creek Formation and the Porcupine Hills Formation. The position of this contact is not known. This photograph was taken to the immediate west of locality 22. Although many units are exposed, the beach is littered with tree

stumps, Pleistocene till, and eroded Cretaceous sediments. These eroded sediments now form multiple "beach" levels, recording the seasonal drops in reservoir water level. The living trees and green ground cover lie approximately 8m above the current water level. High spire gastropods were recovered from a 10cm thick silt- or mudstone unit. The shells are exceedingly delicate and disintegrate as quickly as do the sediments.

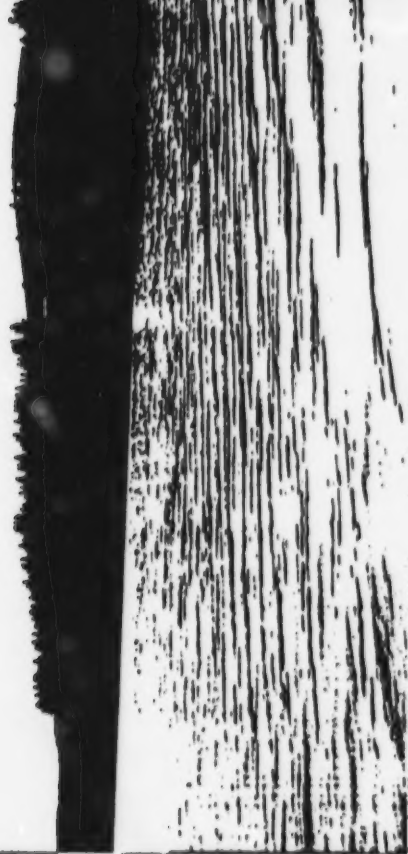
20

Photograph 20: Looking southeast at or very near locality 22, and to the east of photograph 19. The description of this area is much the same as in the previous photograph. The exposed sedimentary rocks of the Willow Creek Formation or Porcupine Hills Formation are riddled with fractures. These sediments break into angular pebble- to cobble-sized chunks.

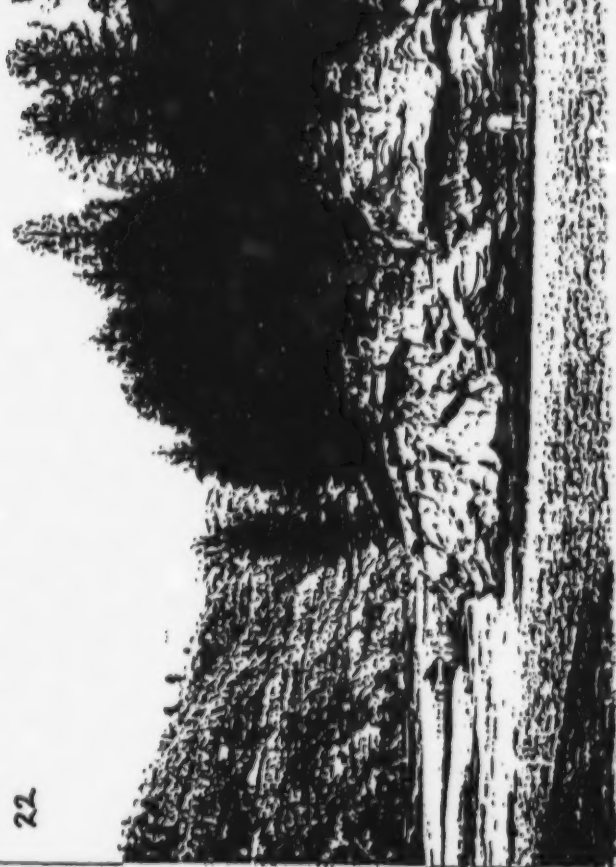
22

Photograph 22: Half way between locality 29 and 30. This section along the Oldman River is approximately at the Full Supply Level for the reservoir. Up river from this point, there had been virtually no change in the outcrops from the initial Carbox

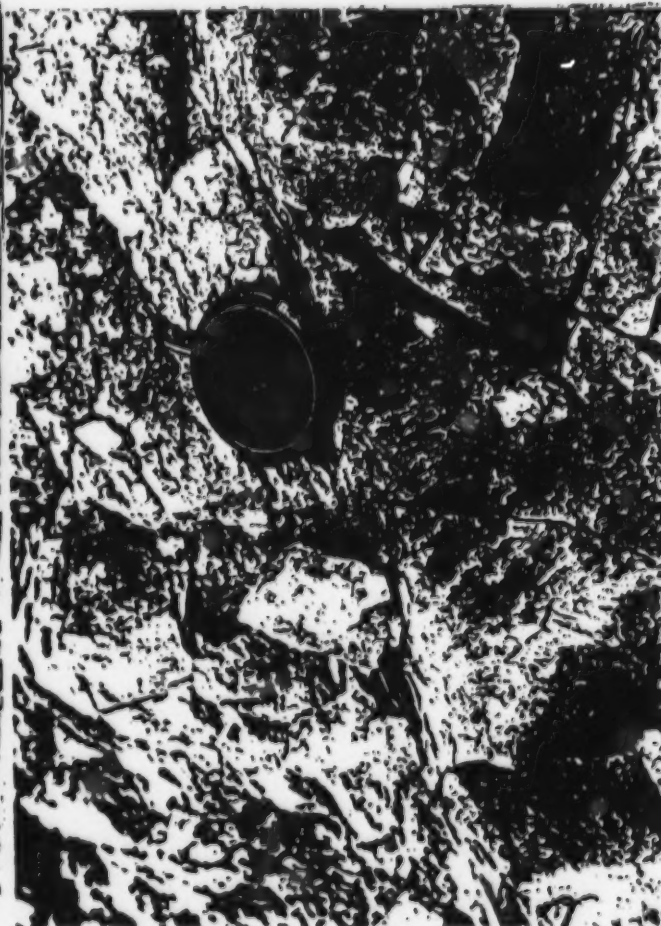
geological report. This shear face of indurated sandstone has experienced little apparent erosion. Photograph 23 was taken from locality 30, which is the large section seen in the left one third of this photograph.

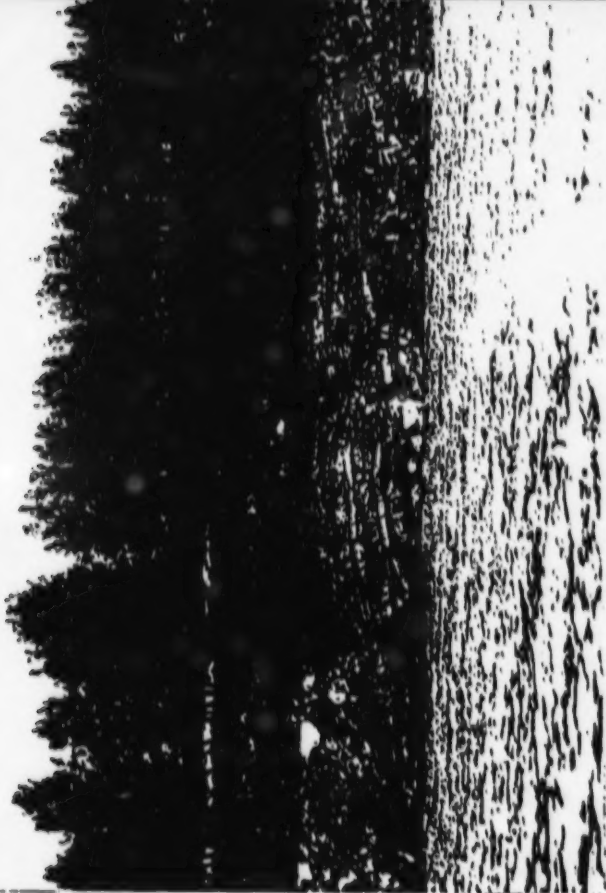
39

line, were not exposed at the time of the Carbex geological study. This area was covered by a stand of Douglas Fir. The more or less in situ stumps support this claim (see photograph 40). It is fairly typical of north-facing exposures. The beach is covered with stumps and tree trunks, multiple mushy muddy "beach" levels and Pleistocene tills. All but the most prominent sandstones of these Tertiary strata are poorly exposed. The exposed sedimentary strata are highly fractured and easily excavated. Water-washed sediments are smeared over much of the section. As the softer sediments are removed from below the massive sandstones, large blocks of the latter then tumble down the bank. Immediately above the current water level of 1110.96m, in the centre of the photograph is an area shown in more detail in Photograph 40. Well-preserved broad leaf impressions were recovered from this site.

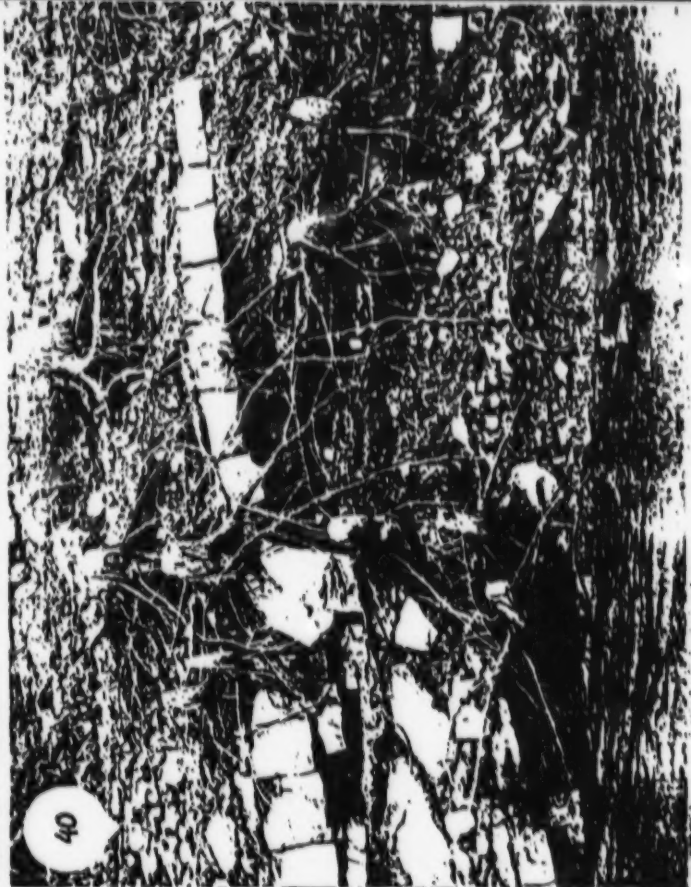
Photograph 39: This newly exposed section lies to the immediate west of locality 37. The strata now exposed below the Full Supply Level, marked by the horizontal line immediately below the tree

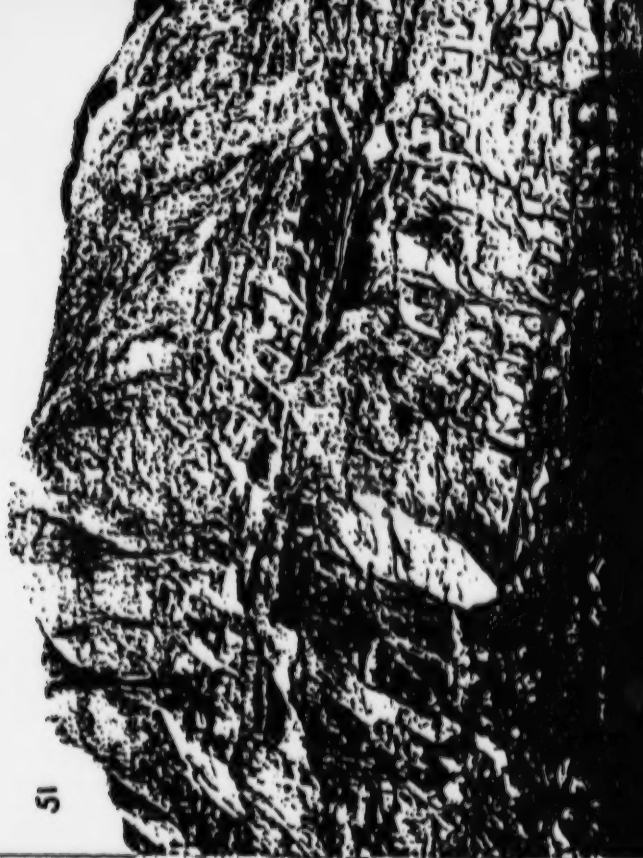
51

Photographs 50 and 51: These two photographs offer a panoramic view of locality 50 (see also Carbex report photograph C48). Although this section is shear, the prominent sandstone units

appear to have kept this exposure relatively intact. The Pogo is 1m long.

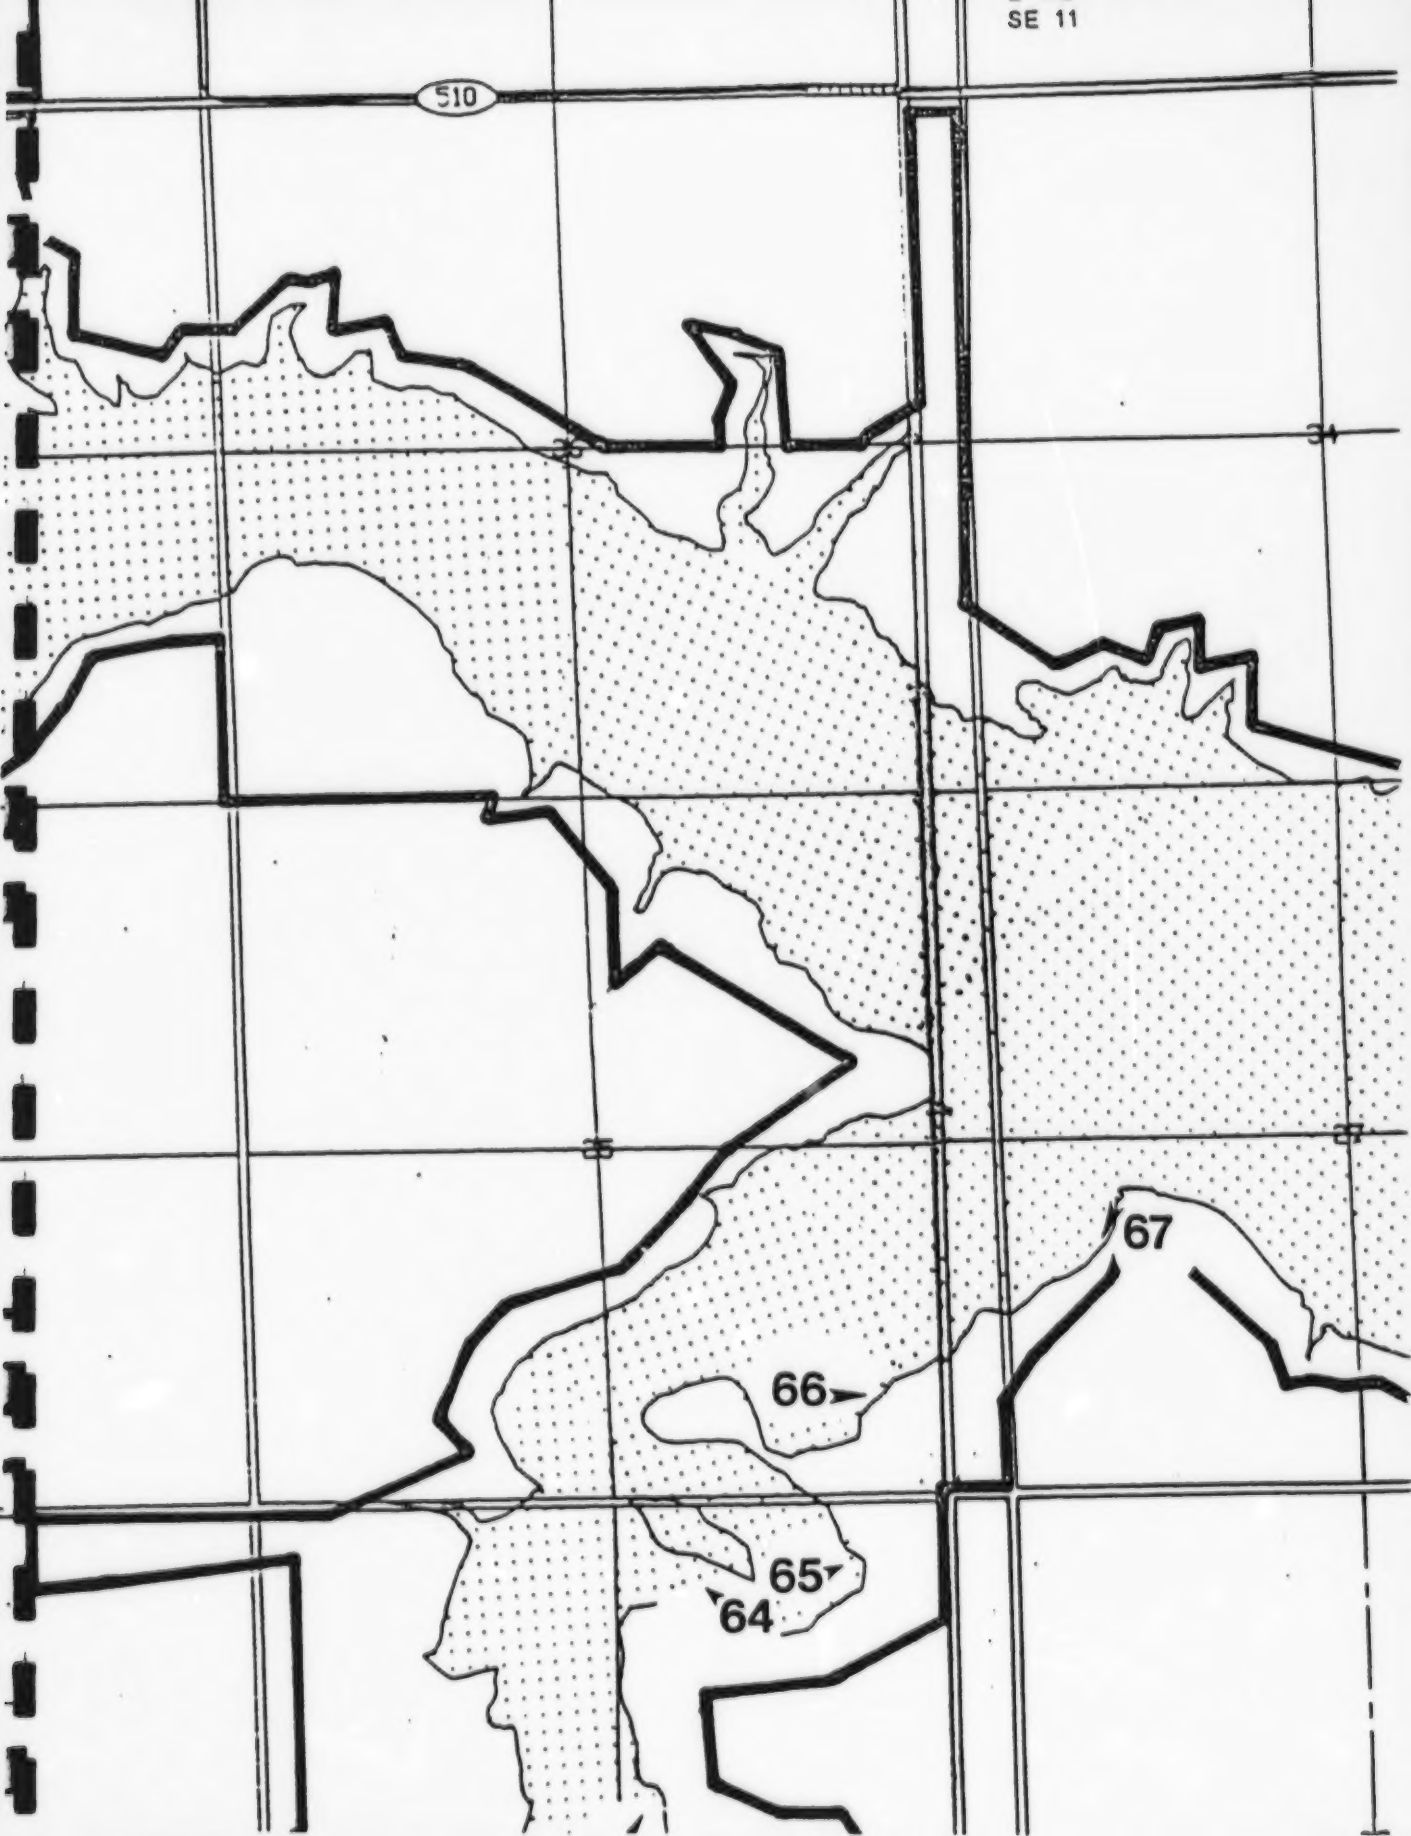
Photograph 61: Looking to the northwest across the Castle River from locality 54 is this relatively small exposure of Porcupine Hills Formation. The beach below the Full Supply Level is heavily littered with eroded sediments and sandstone blocks. This section may correspond to locality 55C in the Carbex report.

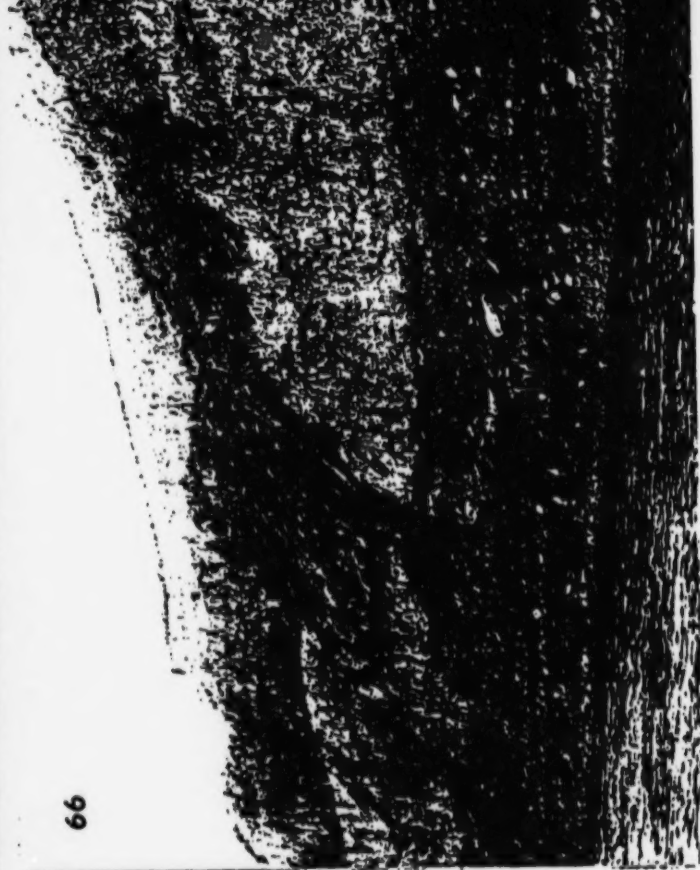
66

Photograph 66: Looking eastward at locality 61, see also Carbex report photograph C73. Most of the lower third of the section consists of shales interbedded with thin sandstones. It is for the most part covered by dirt and cobbles derived from the vast Pleistocene tills forming the upper two thirds of this cliff. No fossils were found at this site. The vertical exposure and the unconsolidated nature of these sediments have resulted in extensive erosion. The Pogo stick is 1m long.

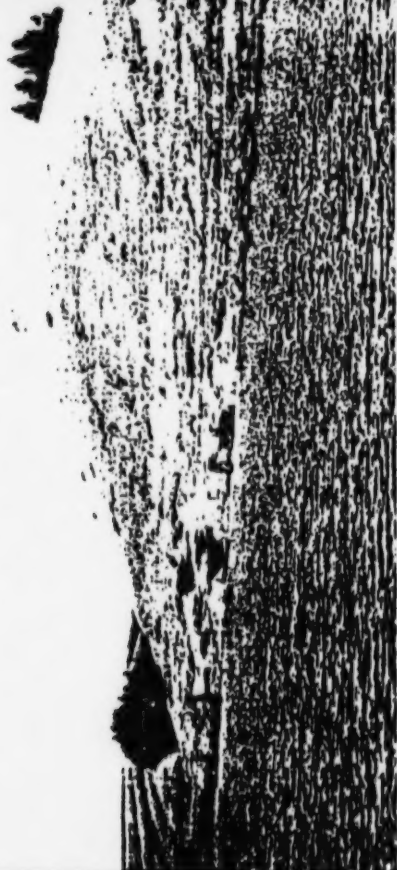
64

Photograph 64: Looking to the northwest at Treasureless Island, the Castle River, and the site of locality 58. The sandstone unit

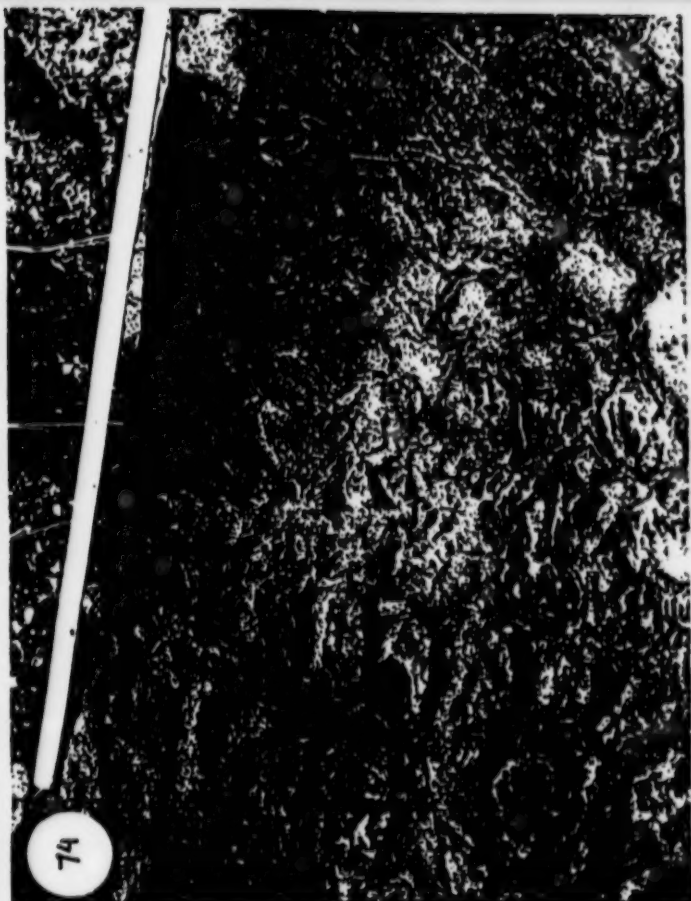
Photograph 75: These in situ tree stumps near locality 71 illustrate to what extent soil and sediments have been removed since the initial flooding of the reservoir. I would estimate that sedimentary material to a depth of between 0.5m to 1m has been

removed from this beach. The Pogo stick is 1m long.

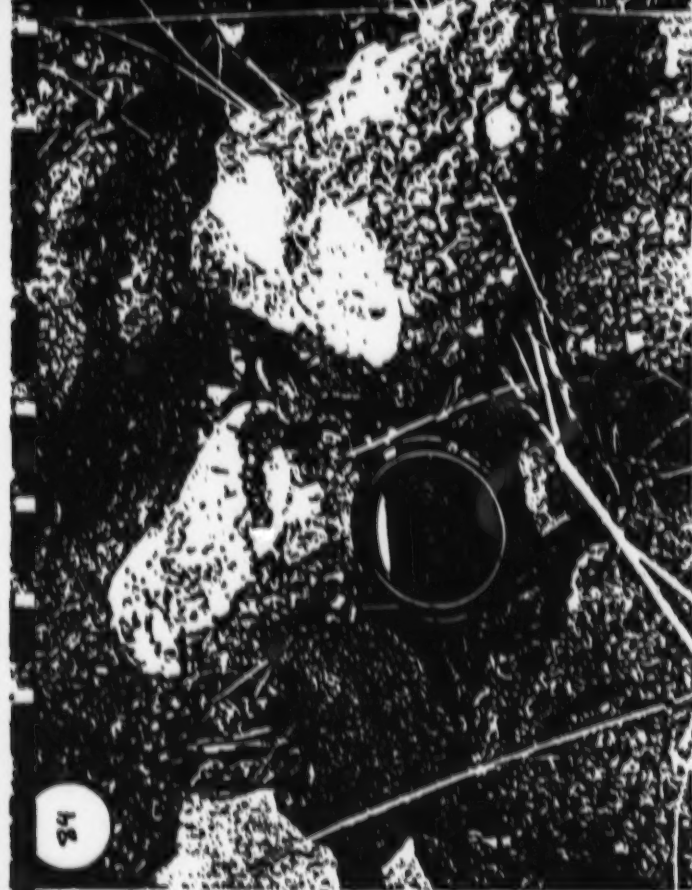
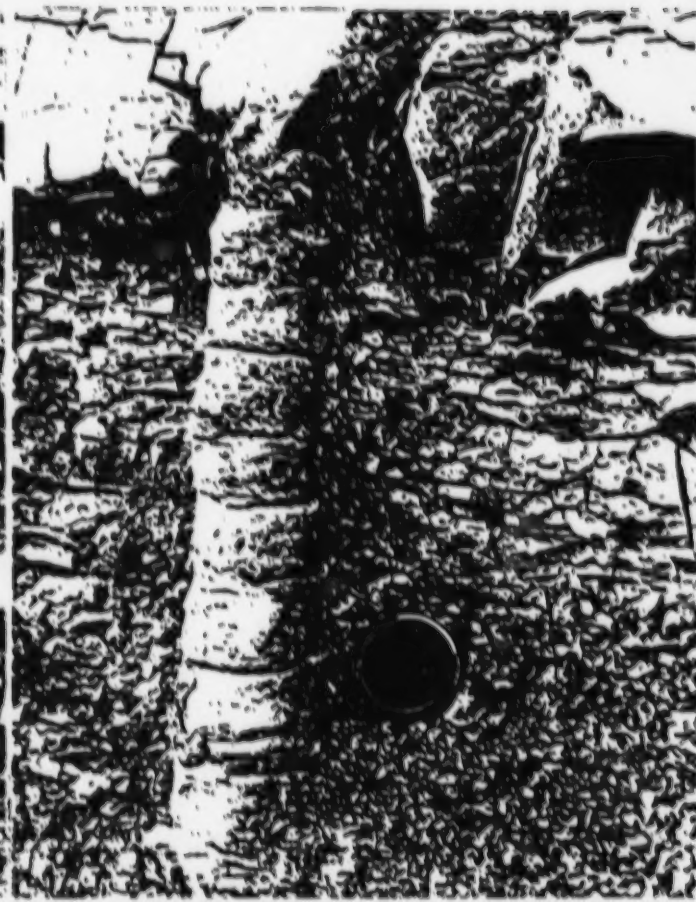
Photographs 83 and 84: Two views of a reddish conglomerate-like and very coarse sandstone which also preserves large bivalves (?unionids) and gastropod shells. These shells are located along the west side of the spillway just beyond the warning billboard and immediately below prairie level. The vertical axis corresponds to the long axis of the photograph in Photograph 83. In Photograph 84, the horizontal axis parallels the long axis of the photograph. The Pogo Stick is 1m long, and the lens cap is 56mm in diameter.

Photograph 85: This vertical burrow was photographed and then

collected. The vertical axis corresponds to the long axis of the photograph. It was discovered immediately below the upper sandstone unit above the access road along the west side of the spillway. The burrow is seen to pass from the sandstone unit down into the darker fine-grained ?shales. Sometime after the burrow was completed, it was infilled by the sandstone which now covers the crumbly shale. The lens cap is 56mm in diameter.
